LESSONS of the STORM

Lessons of the Storm

A Brief Engineering Study

OF THE EFFECTS OF THE RECENT HURRICANE ALONG OUR SOUTHERN COASTS UPON VARIOUS TYPES OF BUILDING CONSTRUCTION

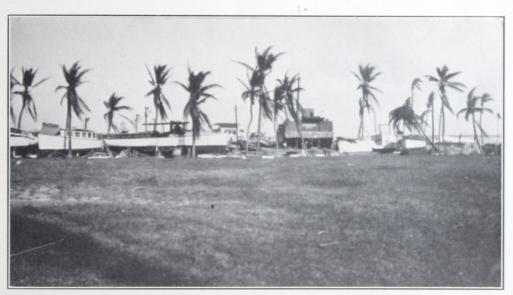
Bay Shore Drive, Miami. Boats and barges driven ashore by wind and water.

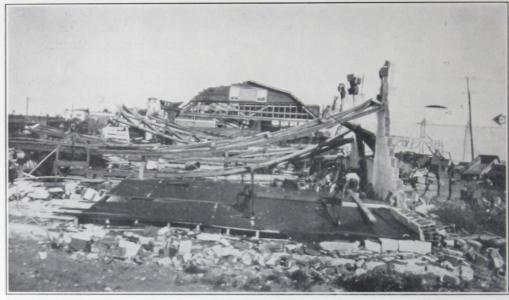
HOLLYWOOD—Ruins of a poorly constructed garage building. Wooden trusses and tile walls with slender reinforced concrete columns. A large number of cars under the wreckage.

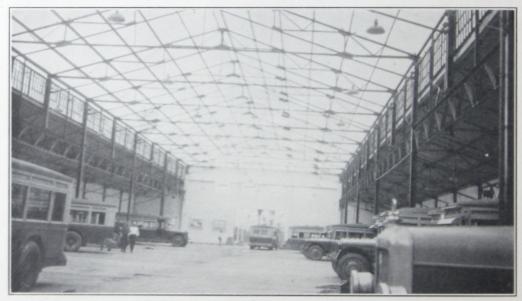
MIAMI—A well designed steel frame garage building. Roof sheeting blown off and a few tile missing from the end wall, but no other apparent damage.

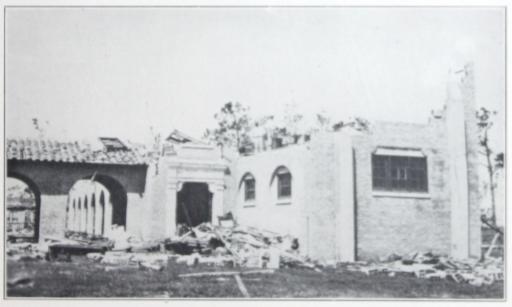
Another view of the High School building, showing additional details of the damage wrought upon this type of construction. Other school buildings in the same group were badly damaged.

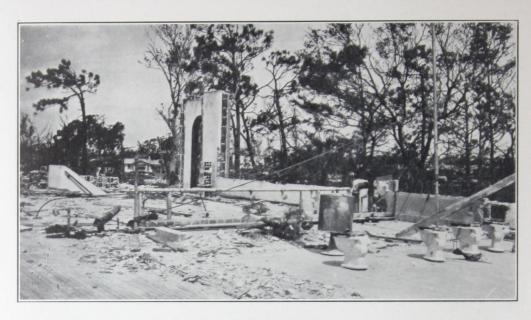
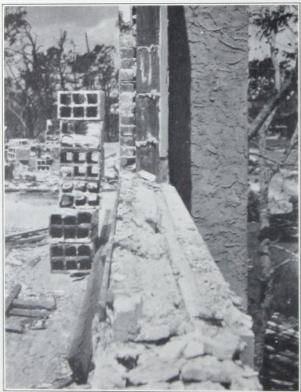
Additional views of the ruins of the High School building. The type of construction shown in detail in the lower picture was common in this district, with cement block frequently substituted for tile.

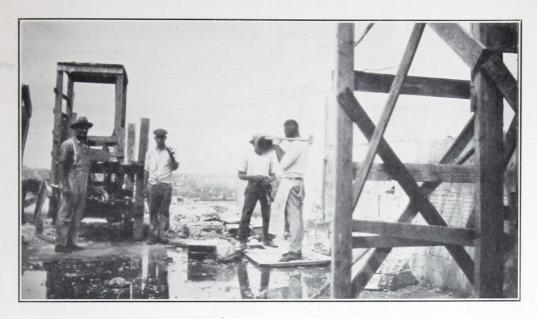
Miami

This is a reinforced concrete building, with tile or concrete block curtain walls.

The roof and walls of the upper story were blown away. Some concrete columns of the upper story remain and are being removed with difficulty.

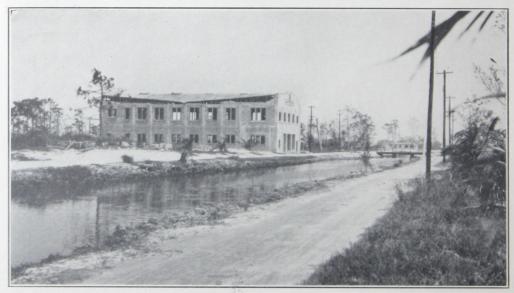
This picture depicts the ruins of Carpenters Hall, an unfinished building. Failure of the upper walls allowed the roof to collapse.

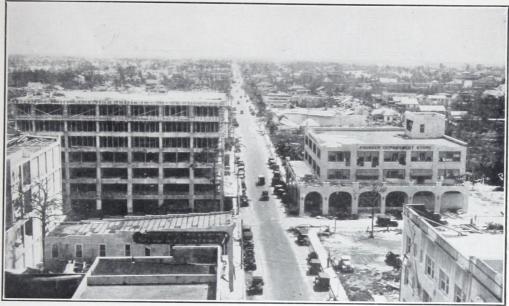
The large building to the left is an unfinished building on which work had been suspended for some months. This was probably due to sudden end of real-estate boom. Buildings badly damaged by storm are also shown.

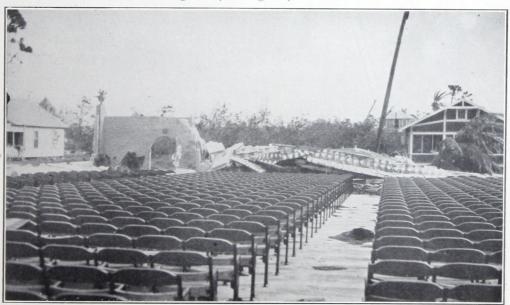
Ruins of open-air Theatre. Walls and band-stand blown down.

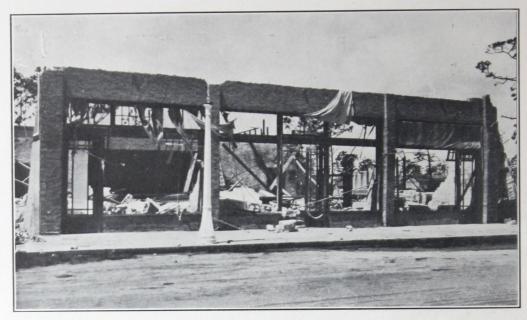
Ruins of Electric Company's building.

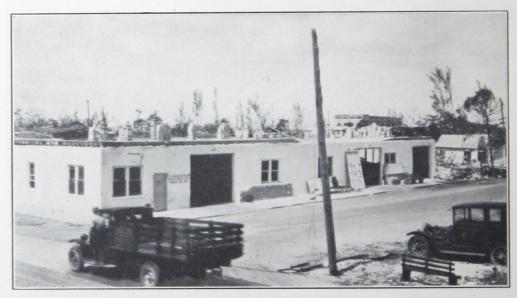
A garage building which had the upper story blown off.

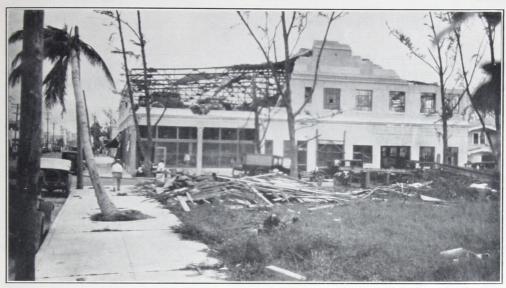
This garage building had roof blown off and walls of upper story badly wrecked. The steel trusses shown were of light design with very light bracing. Although some truss members were bent, none had failed and trusses were in position except as pulled out of line by failure of other portion of structure. Purlins were wood joists.

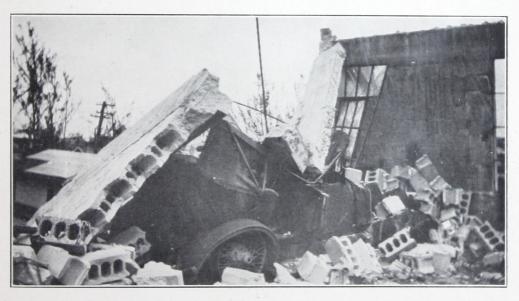
A ruined car on the second floor of building shown above.

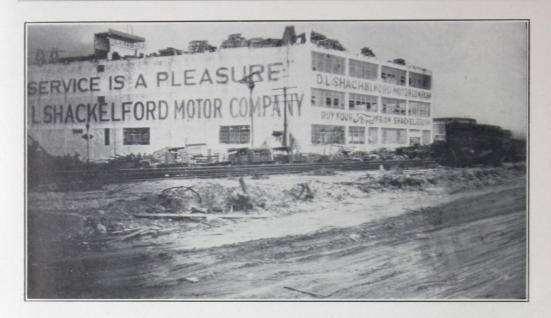
Above — Damaged building of the Schackelford Motor Company.

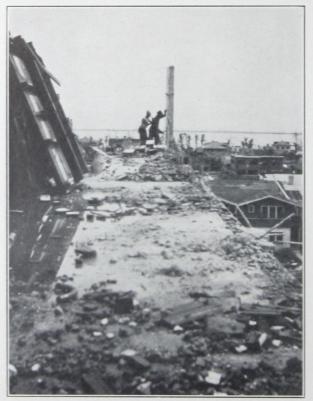
Left — View of upper story of Shackelford Motor Co. building, showing workmen engaged in removing the concrete columns which did not fail.

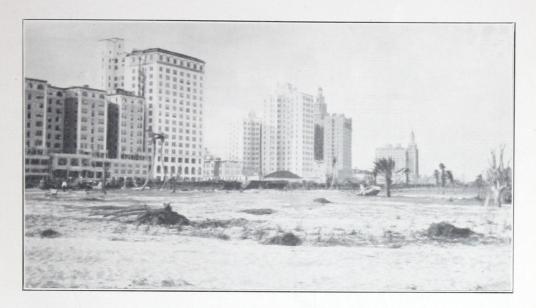
The Bay Shore Drive district of Miami was exposed to the full fury of the storm.

The upper picture shows hotels and office buildings along this celebrated thoroughfare that withstood the hurricane apparently without structural weakening, although damaged by water and flying debris. Barges and small boats are strewn along in front of these big buildings.

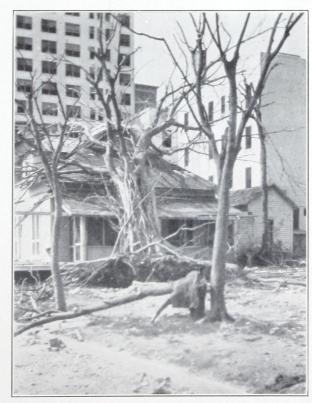
Picture to right shows how bungalows were in many instances damaged by uprooted trees blown against them.

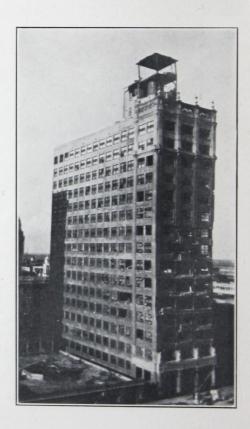
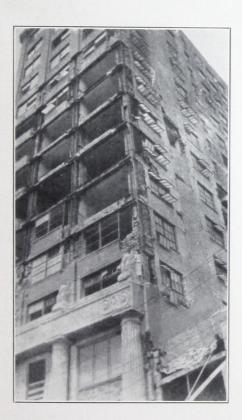
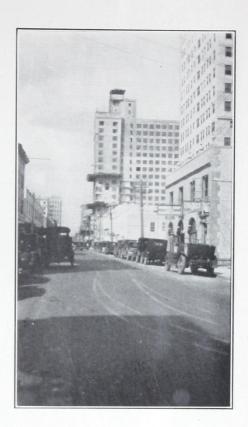
Big buildings of steel frame construction stood up to the storm unyielding, with one notable exception. This was a high, narrow structure accused of having faulty design. After removal of portions of its curtain wall, this building will be subjected to exhaustive studies by engineers to ascertain the causes of its failure.

This building is 17 stories high and less than 50 feet wide in front and 40 feet in the rear Investigations are now in progress as to the cause of the failure and best method of reconstruction.

Views of the Meyer-Kiser Bank and Office Building. This is the outstanding example of tall building failure in the storm-swept area.

Other views of the Meyer-Kiser Bank Building.

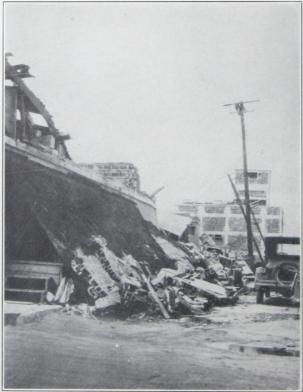
The picture to the left shows the ruins of a grocery store in the Fort Lauderdale district.

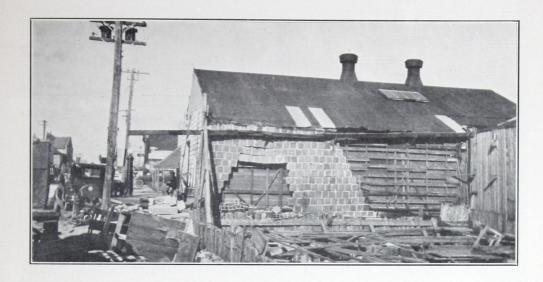
West Palm Beach

The upper picture shows one of the few cases of failure in this vicinity, a careless application of cement block.

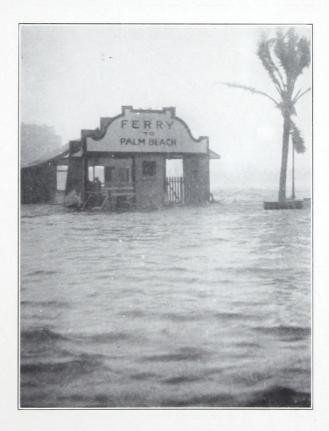
Lower picture shows the floods driven in on West Palm Beach by the fury of the gale.

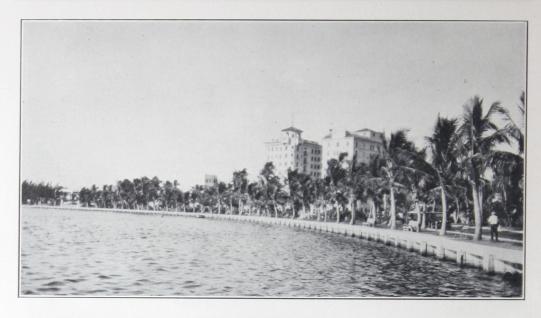
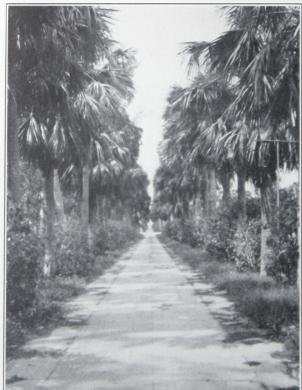
Palm Beach and West Palm Beach

These views show by the condition of the foliage that comparatively little damage was done in this section.

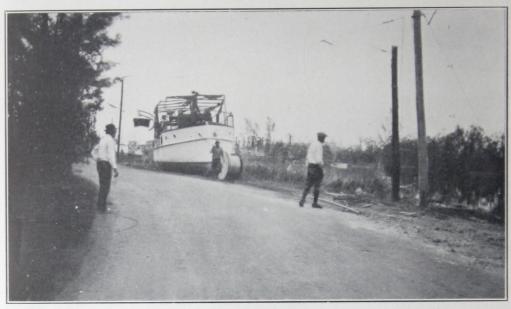
Badly damaged boat washed up on roadway. Workmen are restringing wires which were blown down.

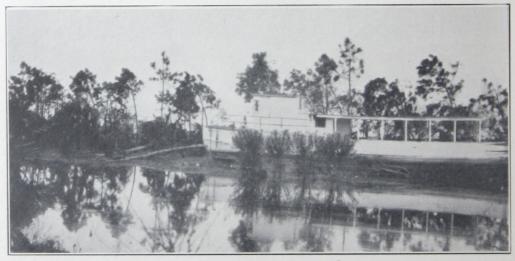
Another damaged boat which was driven over the road shown above, and into adjacent field.

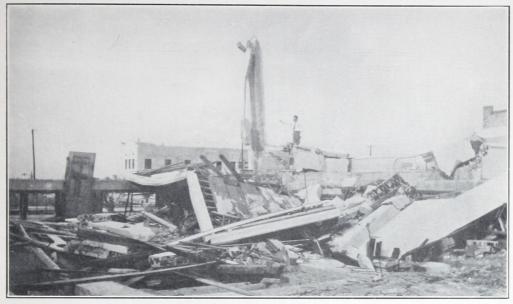
Ruins of Methodist Church. Concrete and tile structure. Failure apparently due to insufficient bracing.

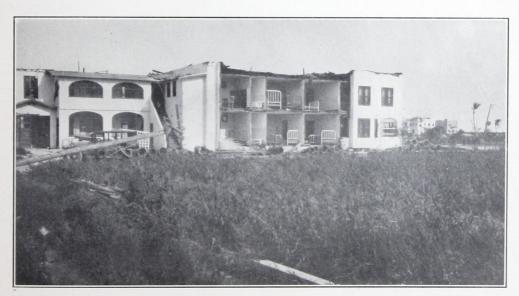
Badly damaged apartment house.
